Section 22 Connecticut

Connecticut Coastal Structures Inventory Study

PHASE I - NEW LONDON COUNTY

APPENDIX B
MYSTIC QUADRANGLE
RECORDS OF STRUCTURES WITH PHOTOGRAPHS

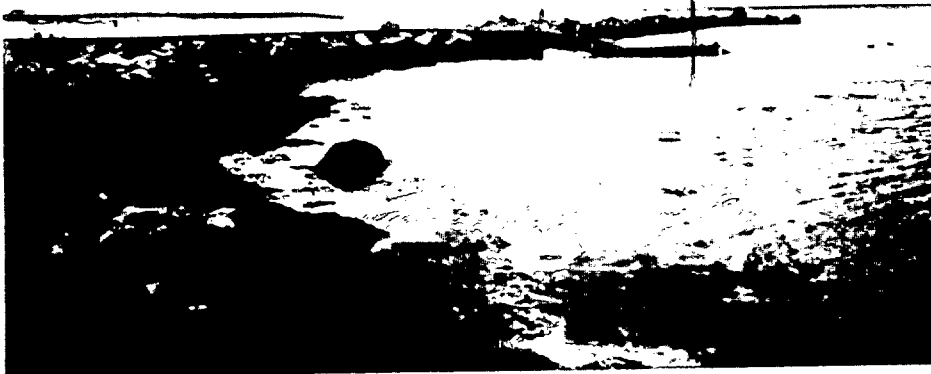
NY 1.20 #1

ACCORDING TO RESIDENT WALL AND GROIN BUILT AFTER HURRICANES
ERODED SHORE FRONT PROPERTY

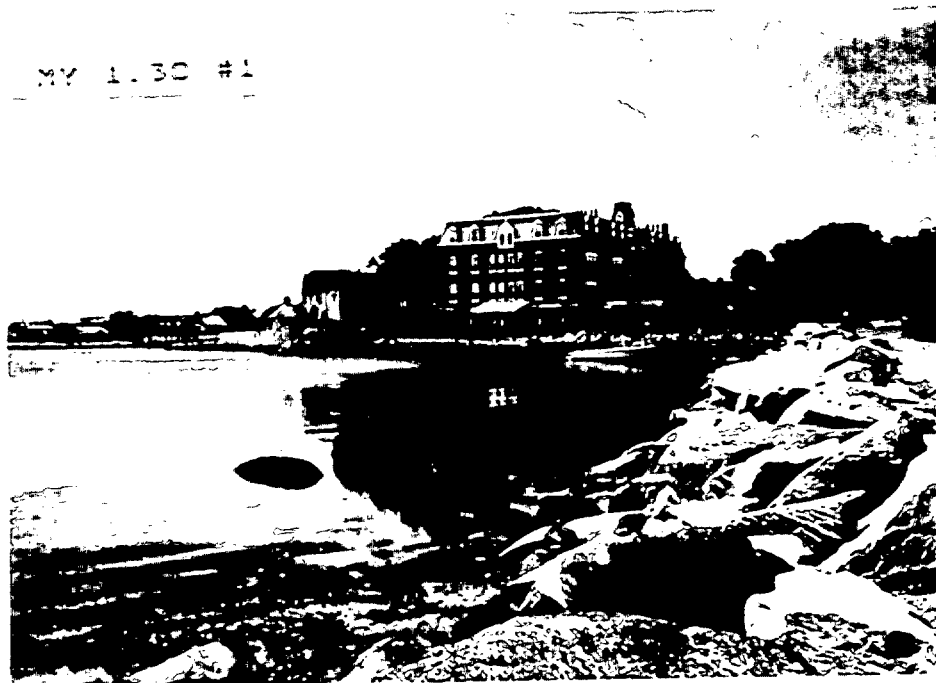
TYPE OF STRUCTURE: SEAWALL CONDITION: GOOD
MAIN FUNCTION : PROTECTION AND RETAINS/SUPPORTS LAND IN FRONT OF R
MATERIAL : STONE&CONCRETE

#1 ROLL 11A NEG 7 SEAWALL WITH ROAD TO EDWARDS POINT ON RIGHT
#2 ROLL 11A NEG 8 SEAWALL FROM SOUTH LOOKING NORTH
#3
#4
#5

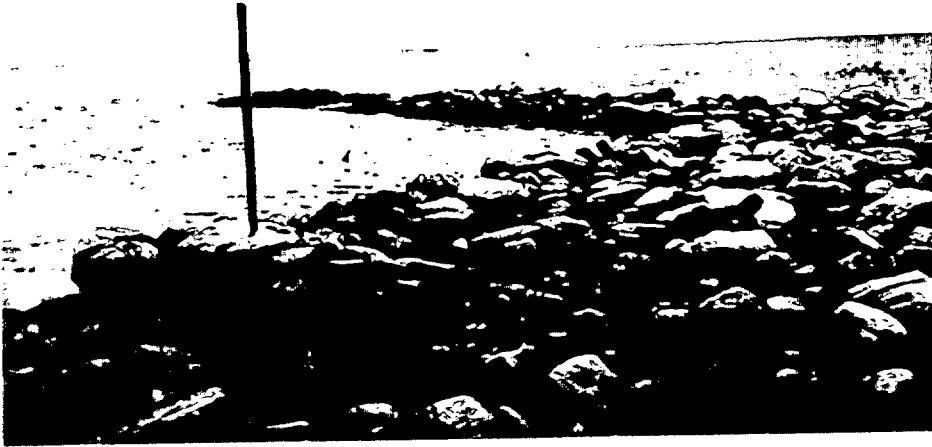
NY 100-42

GROIN EXTENDS OUT FROM EXPOSED BEDROCK SHORELINE AREA

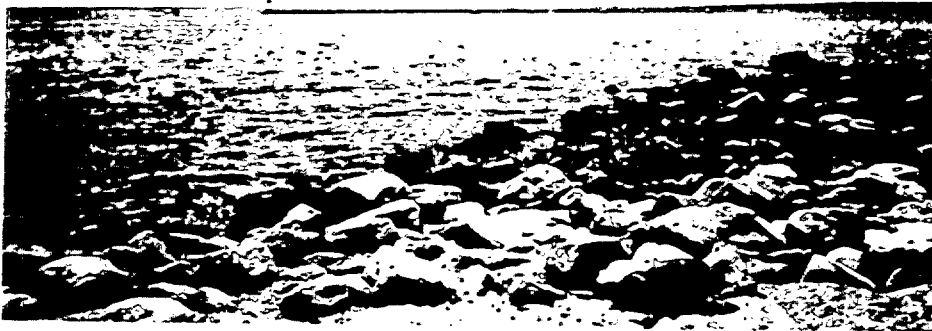
NY 3.00 #1

ONE OF TWO BREAKWATERS PROTECTING STONINGTON HARBOR
STRUCTURE BUILT BY CORPS OF ENGINEERS.

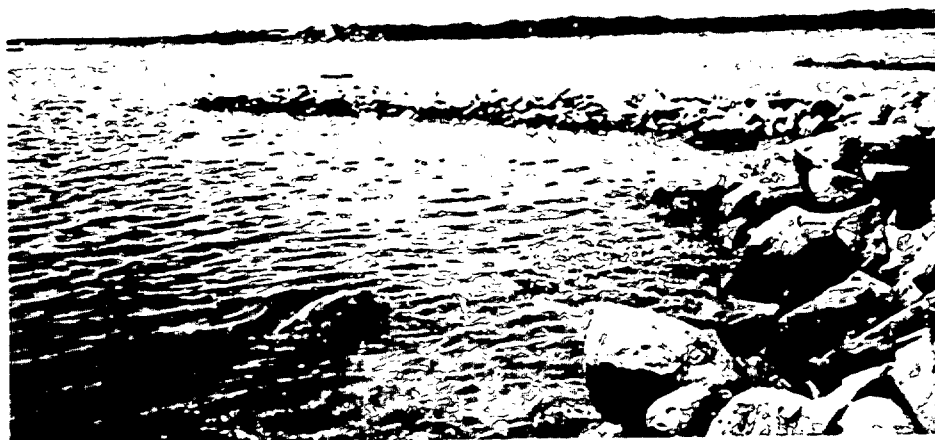
3. 4. 00 #1

NO SEDIMENT TRAPPED ON SOUTH SIDE, BEACH (DU BOIS) FOR
STONINGTON RESIDENTS ON NORTH SIDE

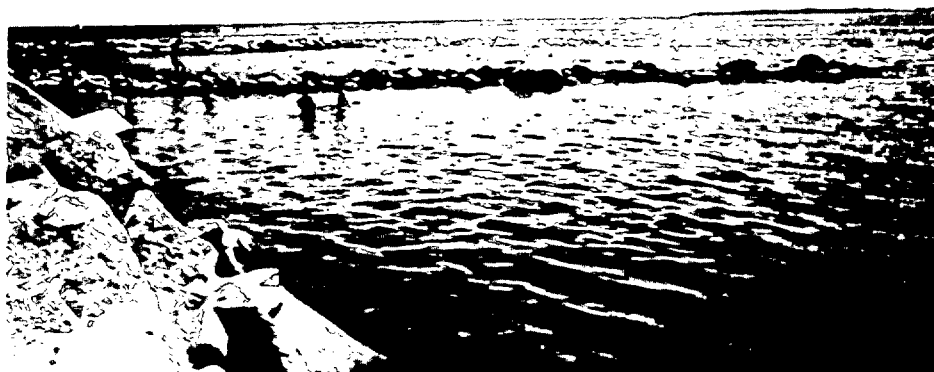
MY 6.20 #1

NO SAND ACCUMULATED ON NORTH SIDE OF GROIN

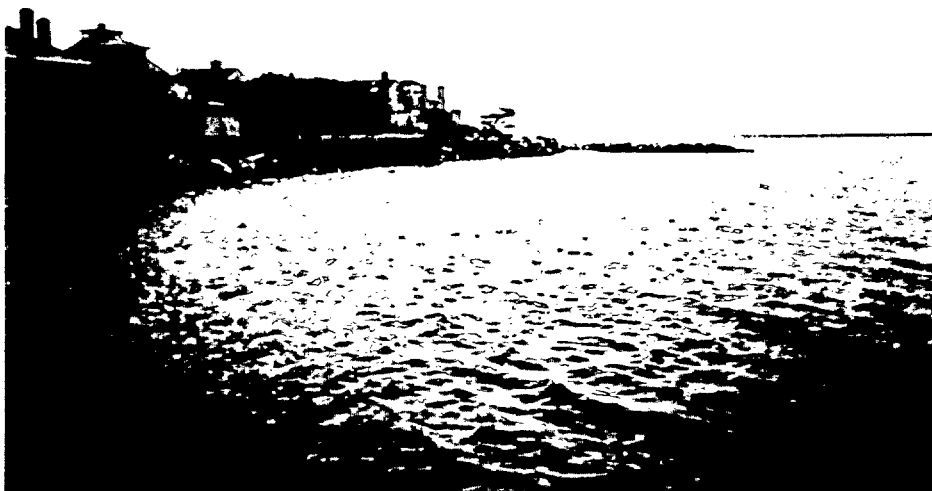
NY 7.03 #1

TYPE OF STRUCTURE: SEAWALL CONDITION: POOR
MAIN FUNCTION : PROTECTS RESIDENTIAL LOTS FROM EROSION, RETAINS LA
MATERIAL : STONE

#1 ROLL 1 NEG 27 SEAWALL FROM STRUCTURE 8
#2 ROLL 2 NEG 2 DAMAGED PORTION OF SEAWALL
#3 ROLL 2 NEG 5 DAMAGED PORTION OF SEAWALL
#4
#5

SEAWALL HAS RUBBLE APRON, PORTION OF SEAWALL DAMAGED

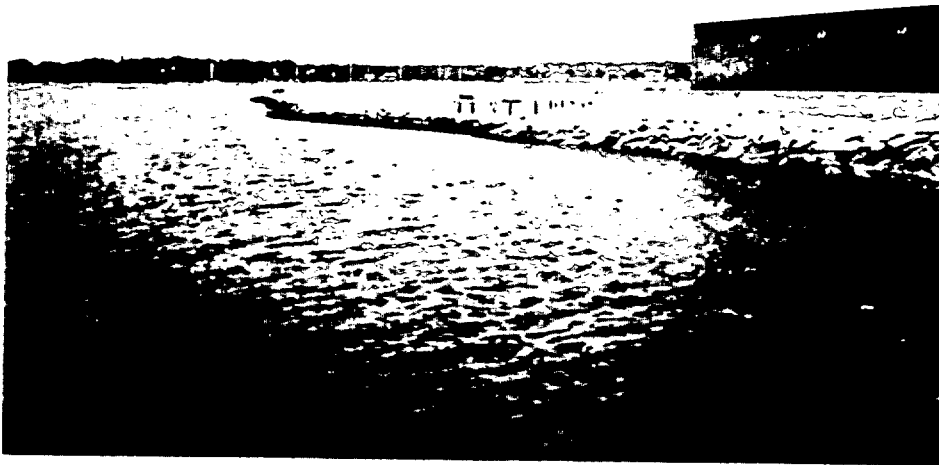
MY 2.00 #1

STONES WERE ORIGINALLY SQUARE TO FIT TOGETHER EVENLY BUT
HAVE BEEN REARRANGED BY WAVE ACTION

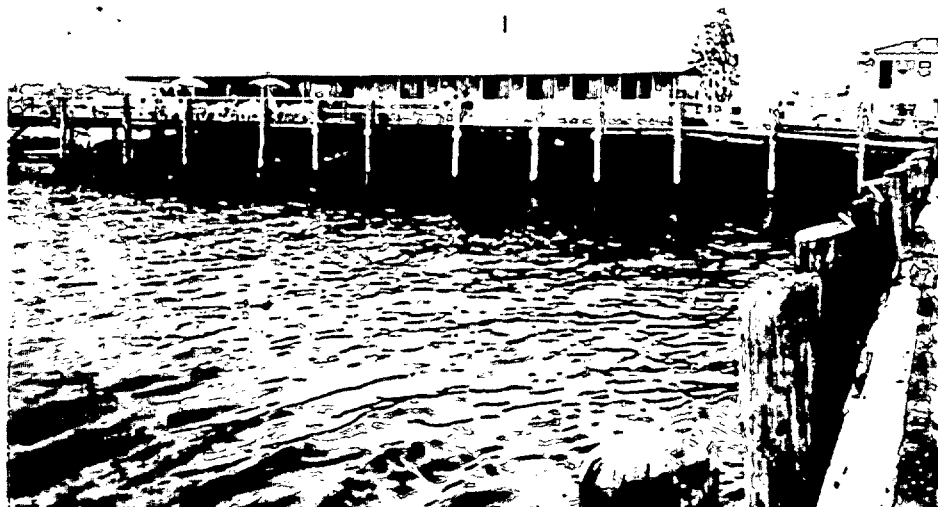
#1 ROLL 2 NEG 10 PIER BULKHEAD AND RESTAURANT FROM SOUTH
#2
#3
#4
#5

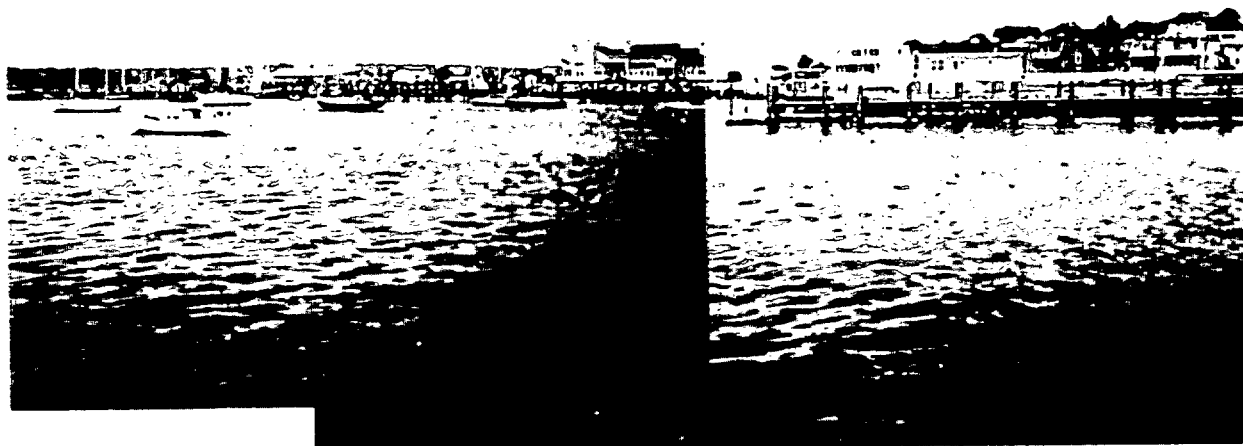
#1 ROLL 2 NEG 11,12,13,14 SERIES OF SMALL SEAWALLS
#2
#3
#4
#5

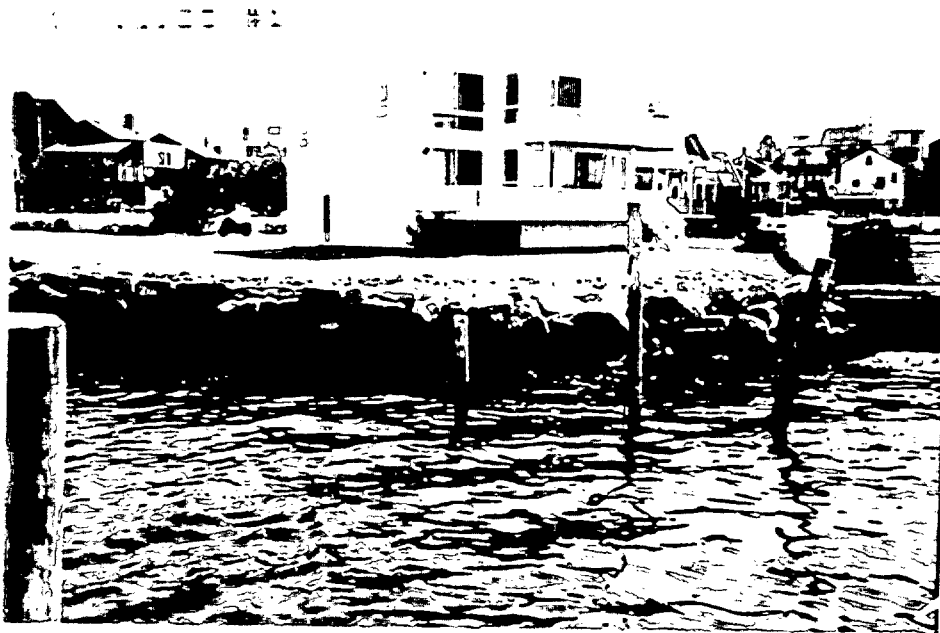
PIER EXTENDS FROM NORTH END OF REVETMENT, 2 DOLPHINS AT
NORTH END OF REVETMENT FOR MOORING PURPOSES

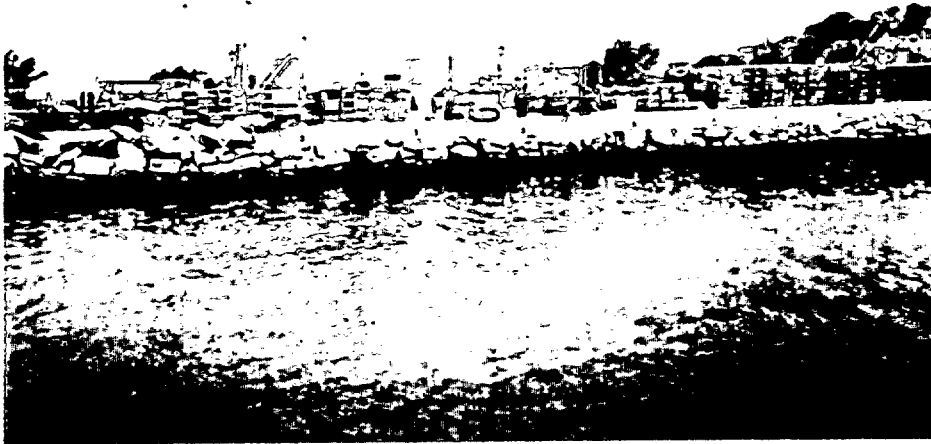
MY 16.03 #1

AREA IMMEDIATELY SOUTH OF STRUCTURE IS AN EXPOSED SANDY
SLOPE USED AS BOAT RAMP TO ALLOW ACCESS TO WATER

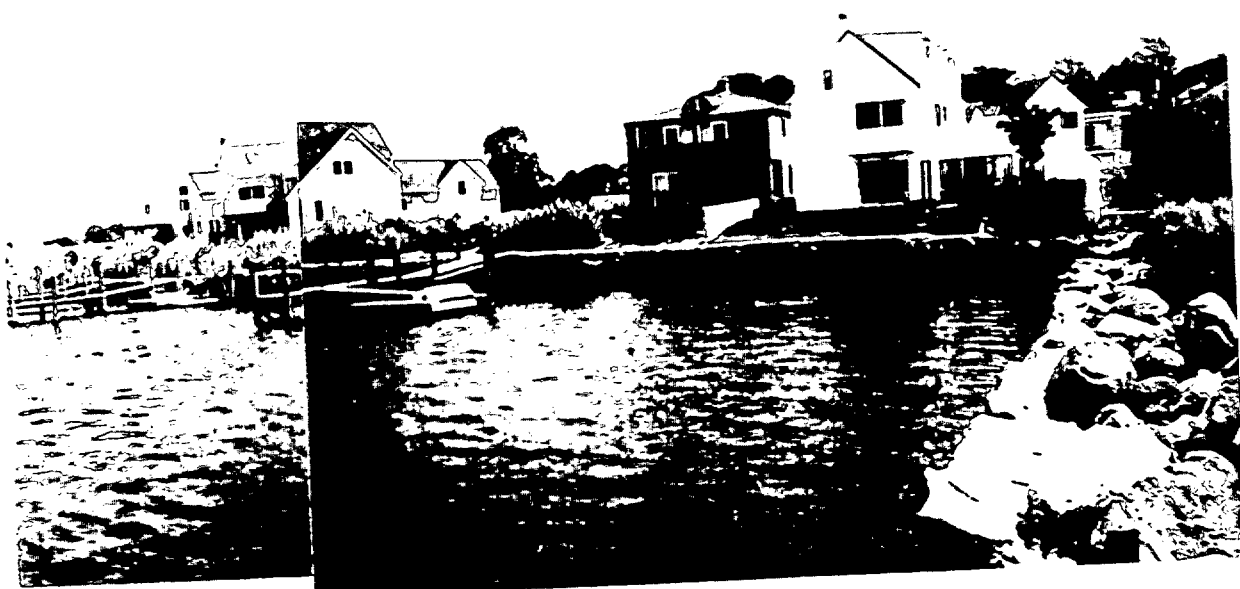
NY 17.00 41

TYPE OF STRUCTURE: SEAWALLS CONDITION:
MAIN FUNCTION : PROTECTION FROM WAVE ACTION, RETAINS LAND
MATERIAL : STONE

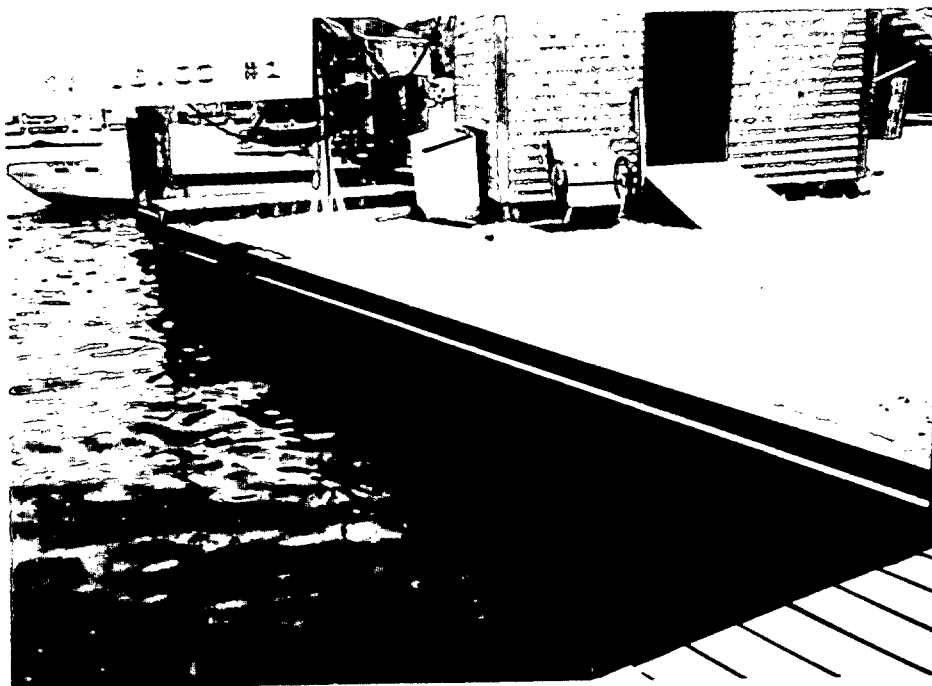
TYPE OF STRUCTURE: BULKHEAD CONDITION: FAIR
MAIN FUNCTION : RETAINS LAND AND PREVENTS EROSION
MATERIAL : STEEL

#1 ROLL 3 NEG 19 STRUCTURE FROM SOUTH END LOOKING NORTH
#2
#3
#4
#5

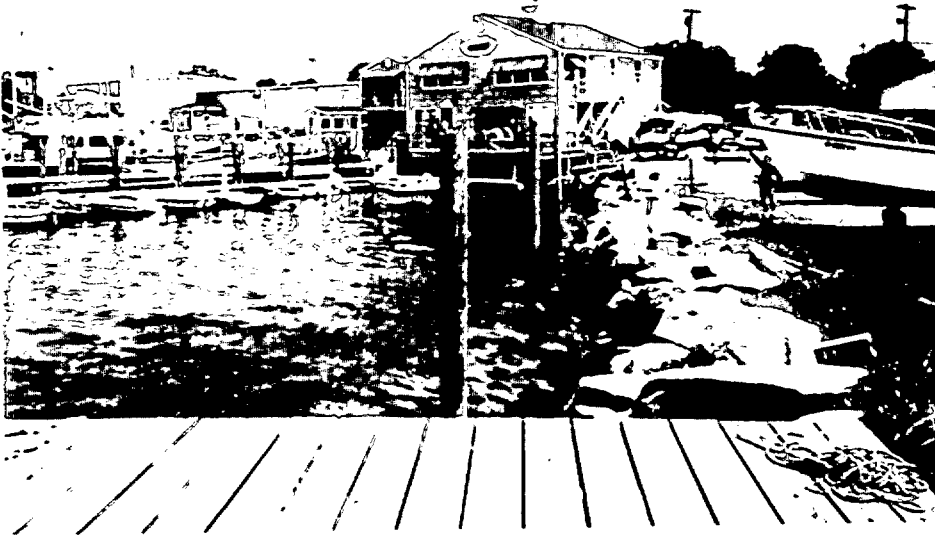
000000 41

SEAWALL EXTENDS FROM STEEL BULKHEAD (STRUCTURE 18) TO
WADAWANUCK CLUB, MOORING AND DOCKING FACILITIES

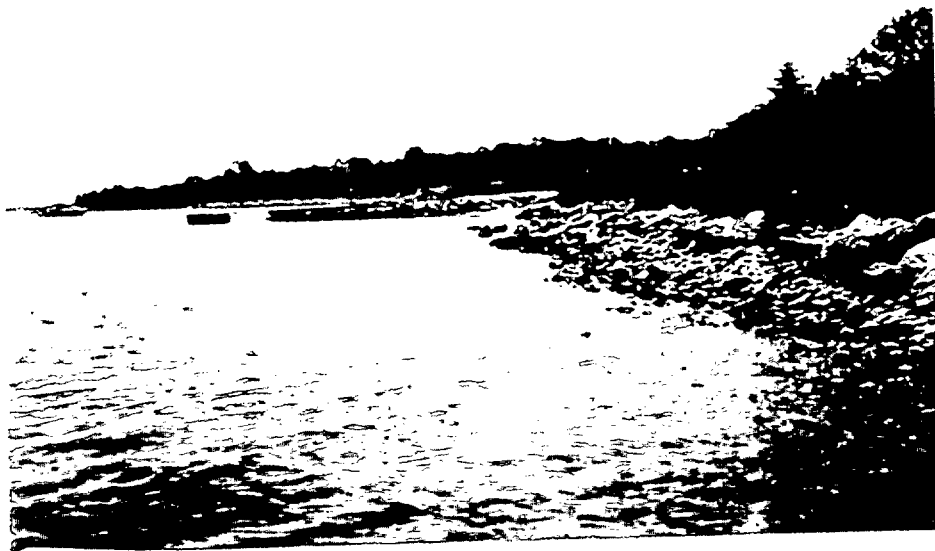
NY 22.00 #1

TYPE OF STRUCTURE: GROIN CONDITION: GOOD
MAIN FUNCTION : RETARDS EROSION OF BEACH TO S. OF GROIN; SECURES
MATERIAL : STONE

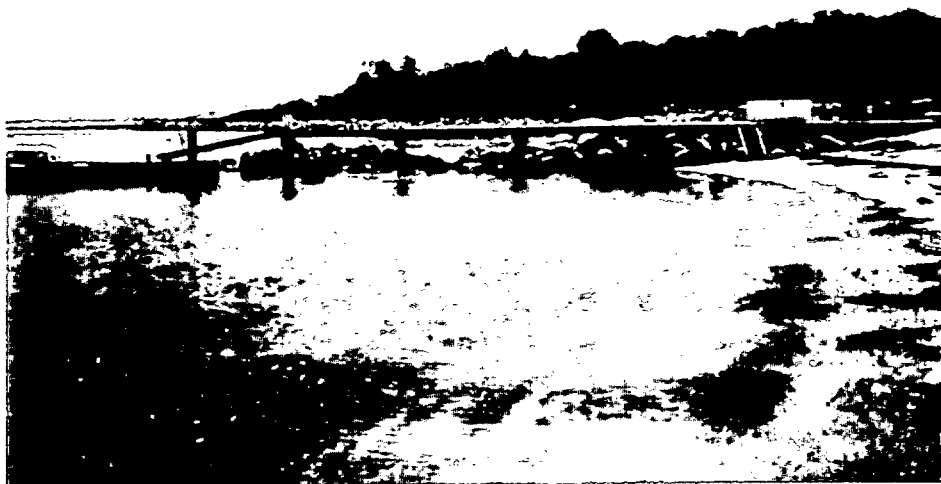
ME 13.00 #1

TYPE OF STRUCTURE: GROIN CONDITION: POOR
MAIN FUNCTION : RETAINS SAND AT BEACH AREA
MATERIAL : STONE

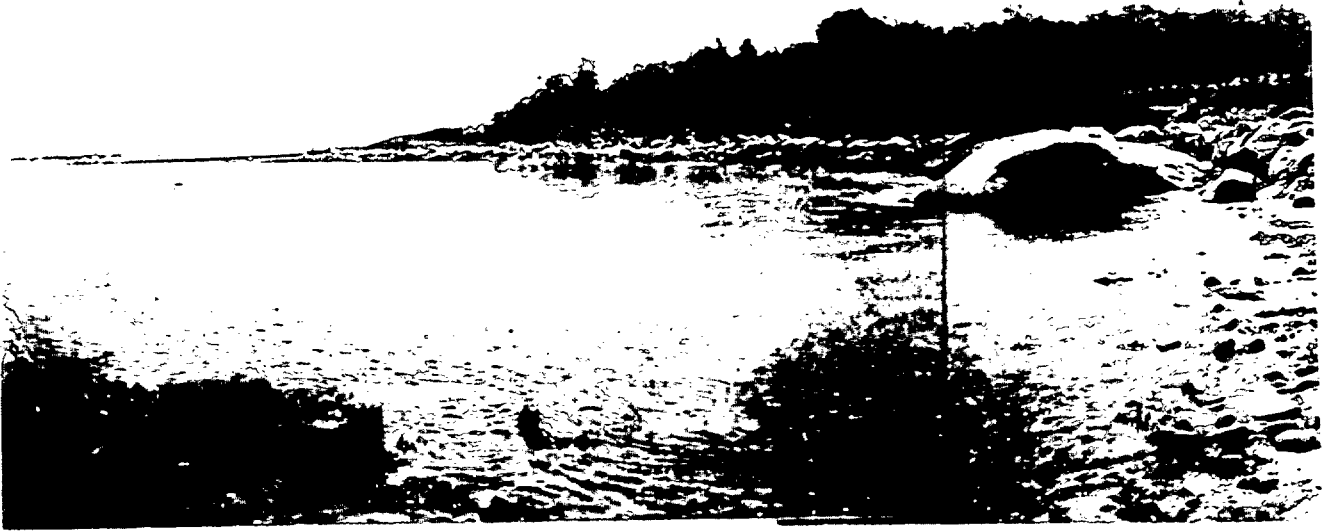
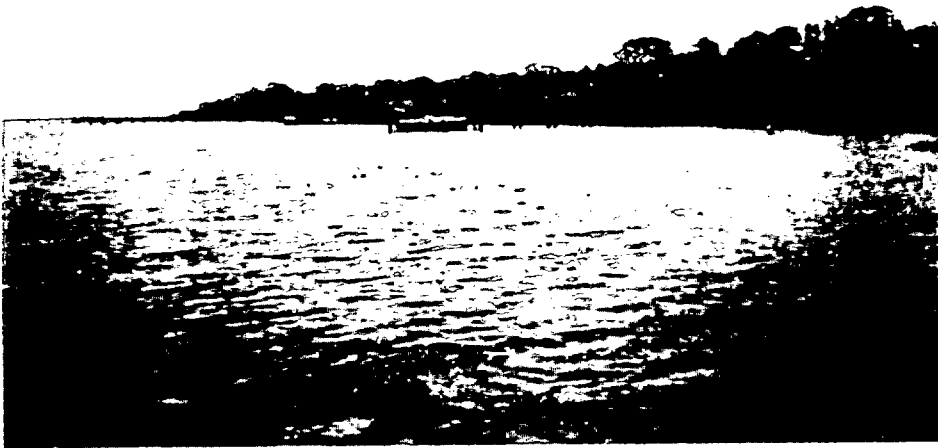
NY 24.10 41

TYPE OF STRUCTURE: RIP RAP SH LINE CONDITION:
MAIN FUNCTION : PROTECTS SHORELINE
MATERIAL :

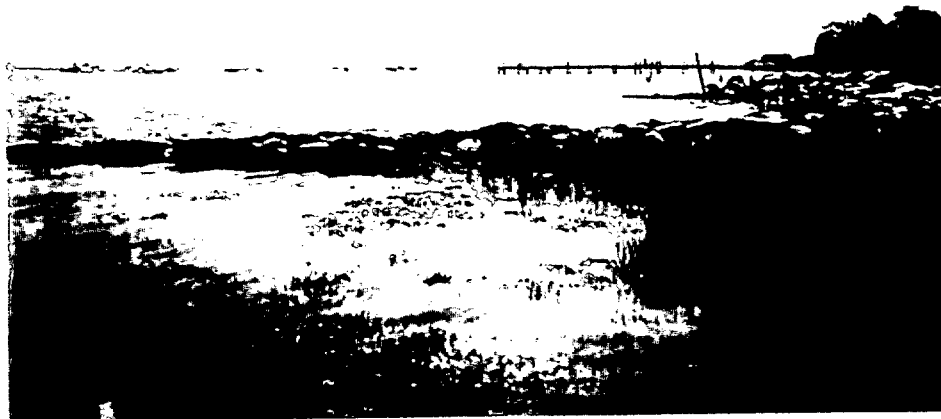
MY 25.00 #1

TYPE OF STRUCTURE: GROIN FIELD CONDITION: POOR
MAIN FUNCTION : ACCUMULATES AND RETAINS SANDY BEACH IN A TYPICAL R
MATERIAL : ROCK

THE GROIN FIELD IS A SYSTEM OF 4 ROCK GROINS IN POOR CONDI-
TION HOWEVER SOME SAND HAS ACCRETED
LOCATED APPROX. 80 YDS S. OF STRUCTURE PREVIOUSLY NOTED

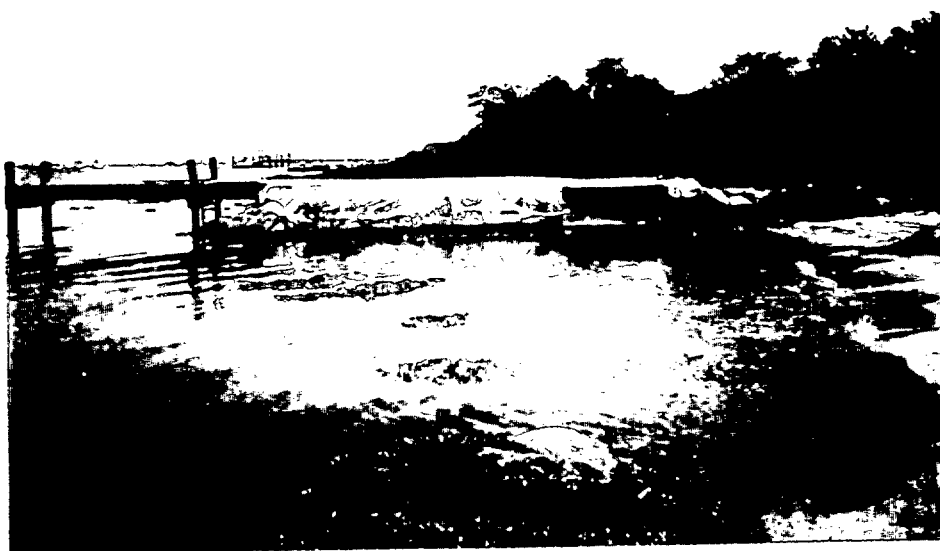
MY 26.22 41

TYPE OF STRUCTURE: BULKHEAD CONDITION: GOOD
MAIN FUNCTION : MAINTAINS BEACH AND SUPPORTS DOCK CONSTRUCTION
MATERIAL : CEMENT

SOUTH SIDE OF STRUCTURE IS GRASSY MARSH AREA. STRUCTURE IS
LOCATED 60-70 YDS S. OF LAST GROIN IN #25 GROIN FIELD.

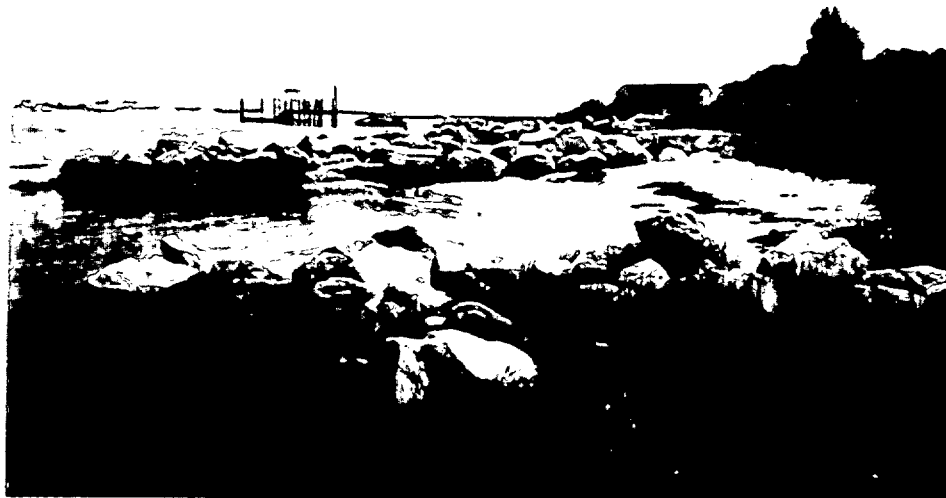
MR 27.00 #1

TYPE OF STRUCTURE: 3 GROINS CONDITION: POOR
MAIN FUNCTION : RETAINS, ACCRETES SANDY BEACH IN PLACE OF GRASSY M
MATERIAL : ROCK

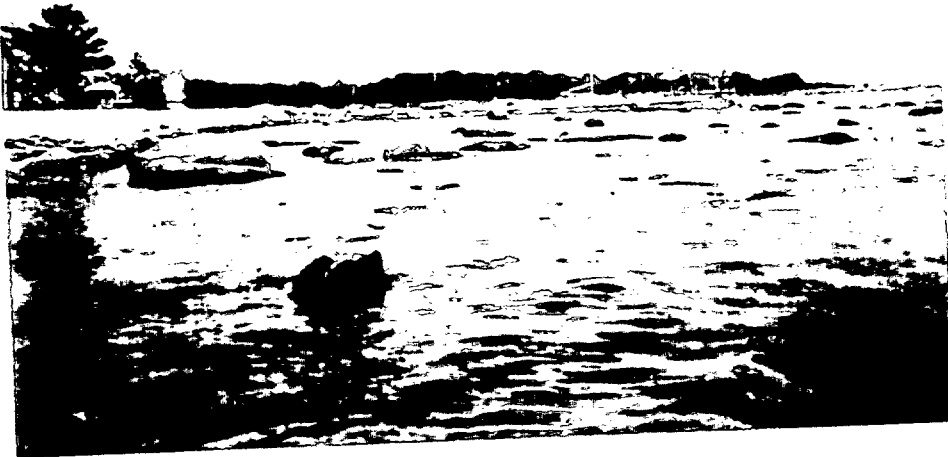
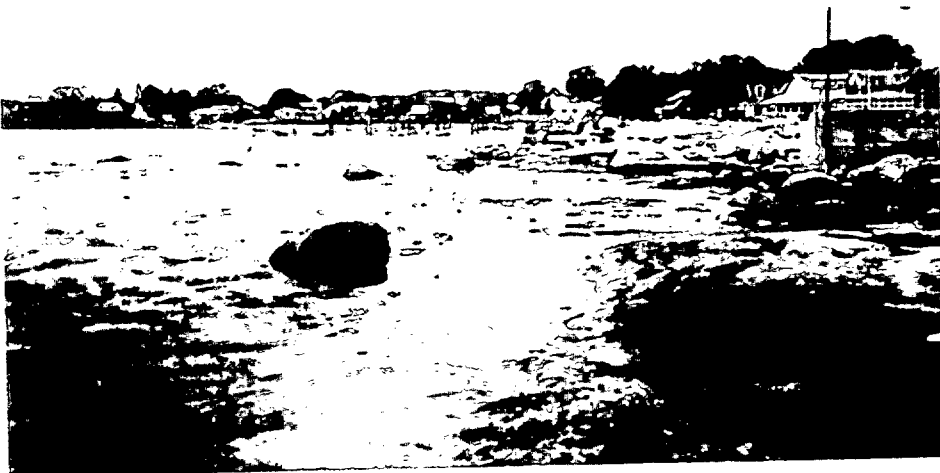
NY 21.10 #1

TYPE OF STRUCTURE: SEAWALL CONDITION:
MAIN FUNCTION : PROTECTS RESIDENTIAL LOTS FROM WAVE ACTION DURING
MATERIAL : CONCRETE

SHORE IS COMPOSED OF EXPOSED BEDROCK

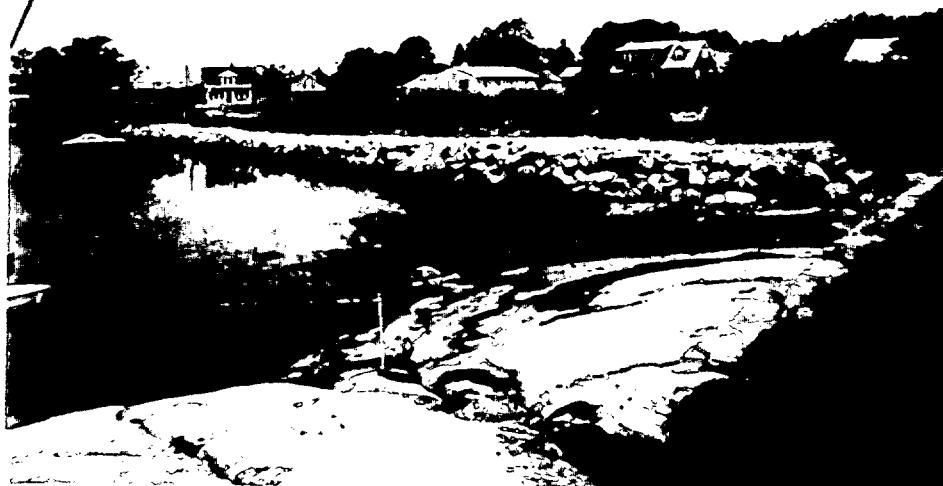
MY 23.20 #1

TYPE OF STRUCTURE: REVETMENT CONDITION:
MAIN FUNCTION : PROTECTS ACCESS ROAD FROM EROSION
MATERIAL : STONE

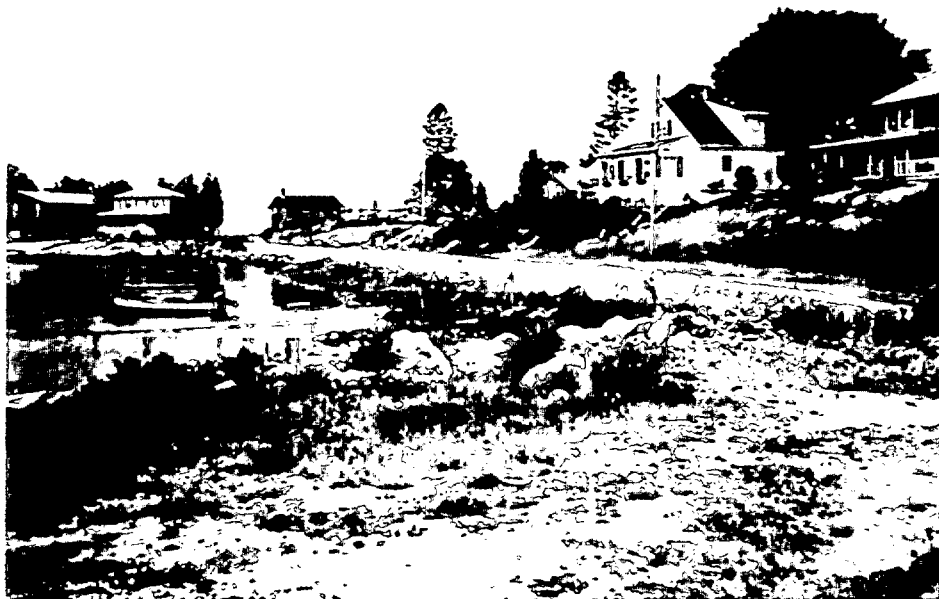
MY 29.00 #1

TYPE OF STRUCTURE: SEAWALL CONDITION: GOOD
MAIN FUNCTION : PROTECTS ROAD FROM WAVE ACTION
MATERIAL : STONE IN CEMENT

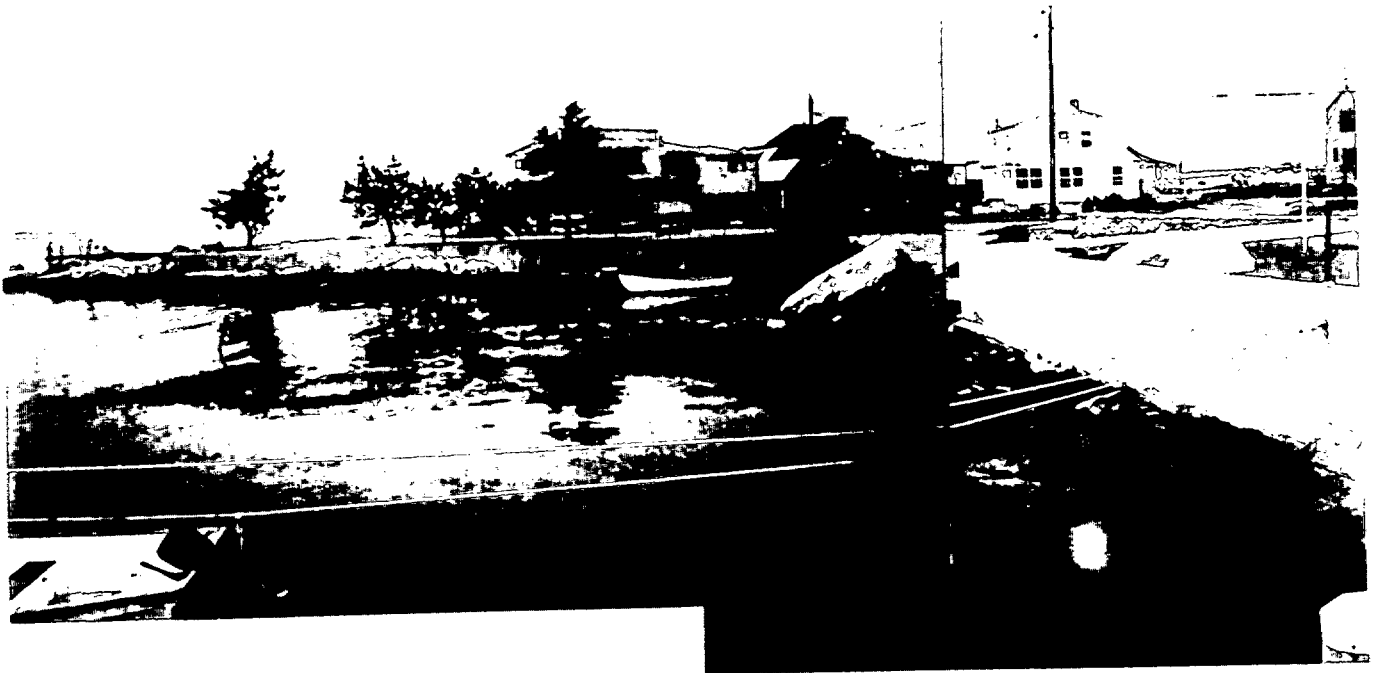
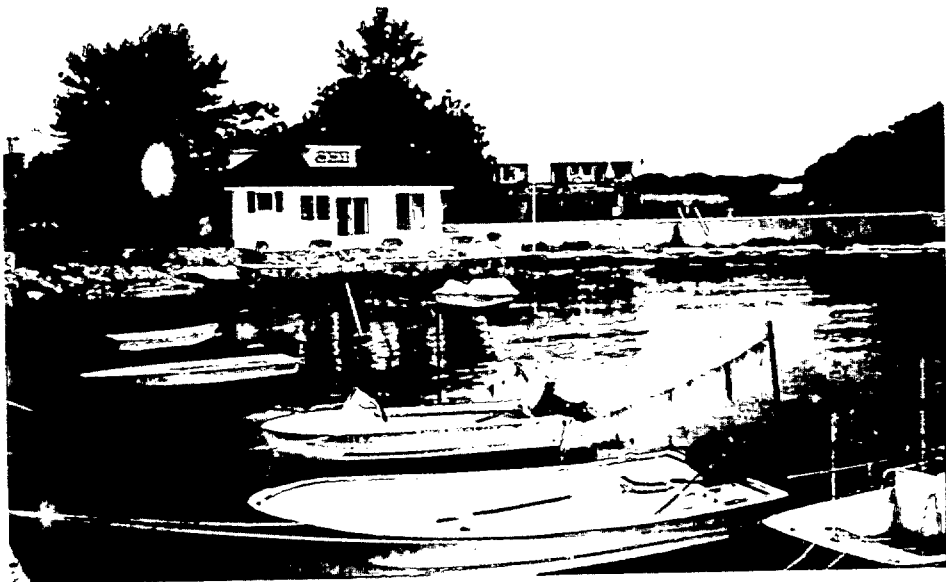
MY 10.00 #1

TYPE OF STRUCTURE: SEAWALLS (5) CONDITION: GOOD
MAIN FUNCTION : PROTECTS RESIDENTIAL LOTS FROM WAVE ACTION; RETAIN
MATERIAL : CONCRETE/ST.CEM

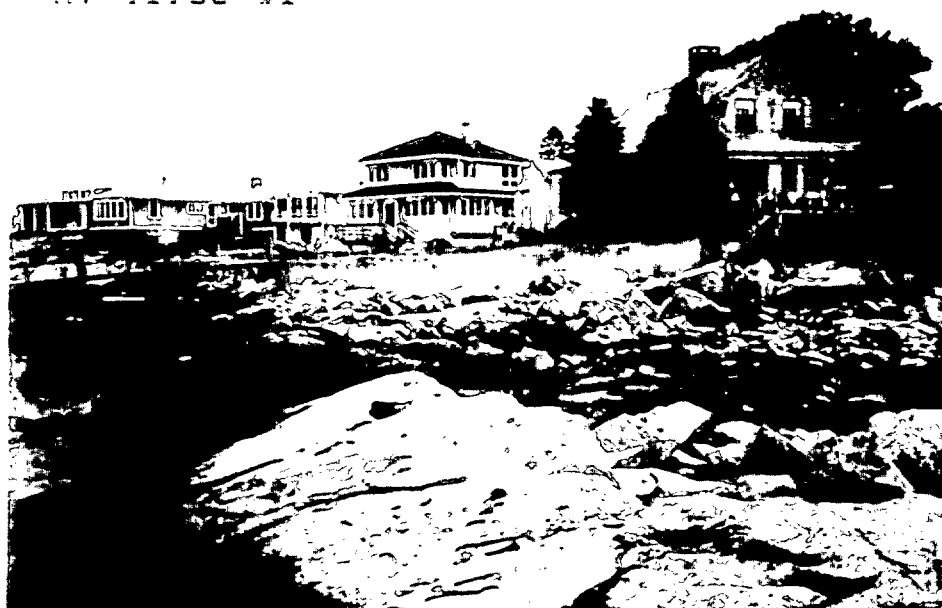
NY 11.00 #1

TYPE OF STRUCTURE: SEAWALL CONDITION: GOOD

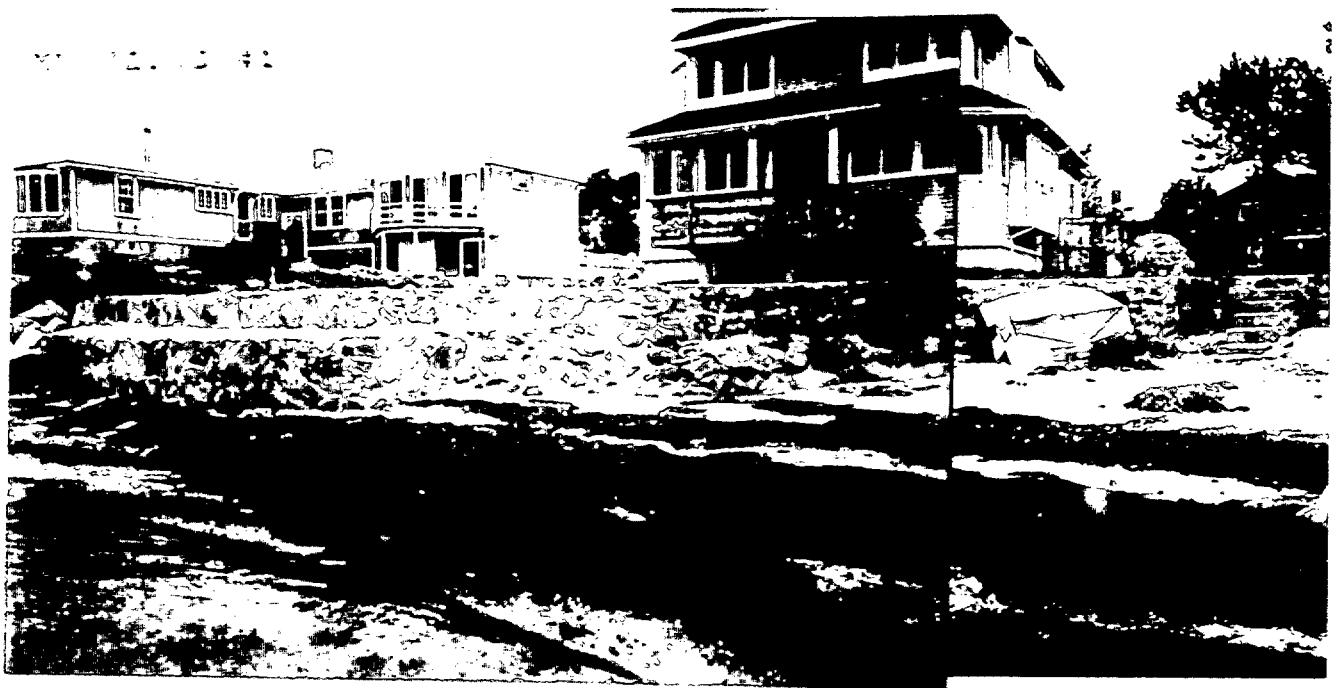
TYPE OF STRUCTURE: SEAWALL CONDITION: GOOD
MAIN FUNCTION : RETAINS/MAINTAINS PRIVATE LOT
MATERIAL : STONE IN CONCRE

#1 ROLL 4 19-20 SEAWALL AND SMALL PRIVATE BEACH
#2
#3
#4
#5

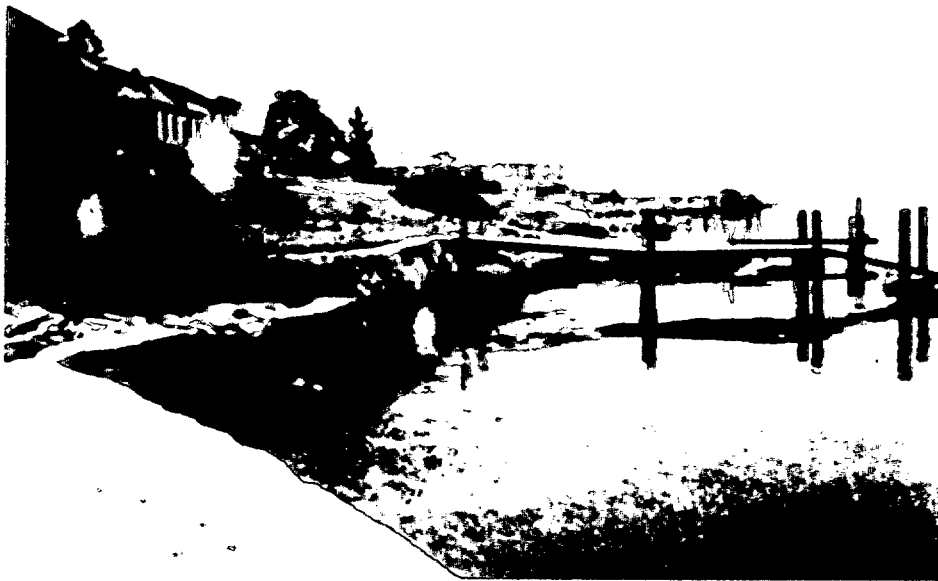
NY 73.00 #1

TYPE OF STRUCTURE: SEAWALLS-SERIES CONDITION: FAIR
MAIN FUNCTION : MAINTAINS/RETAINS PRIVATE LOTS
MATERIAL : STONE IN CONCRE

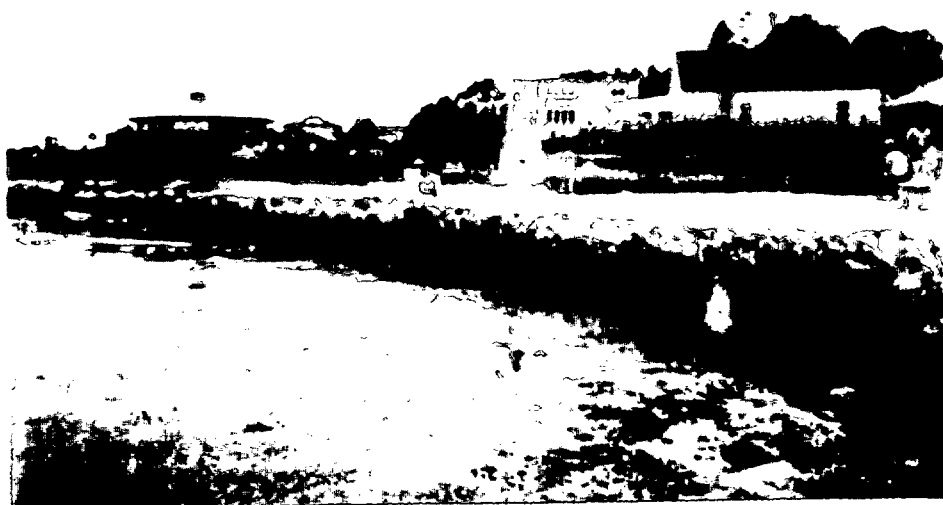
NY 34.10 #1

TYPE OF STRUCTURE: SEAWALL CONDITION: FAIR
MAIN FUNCTION : MAINTAINS LORD'S PT ASSOC. PROPERTY TO PREVENT FLD
MATERIAL : STONE&CONCRETE

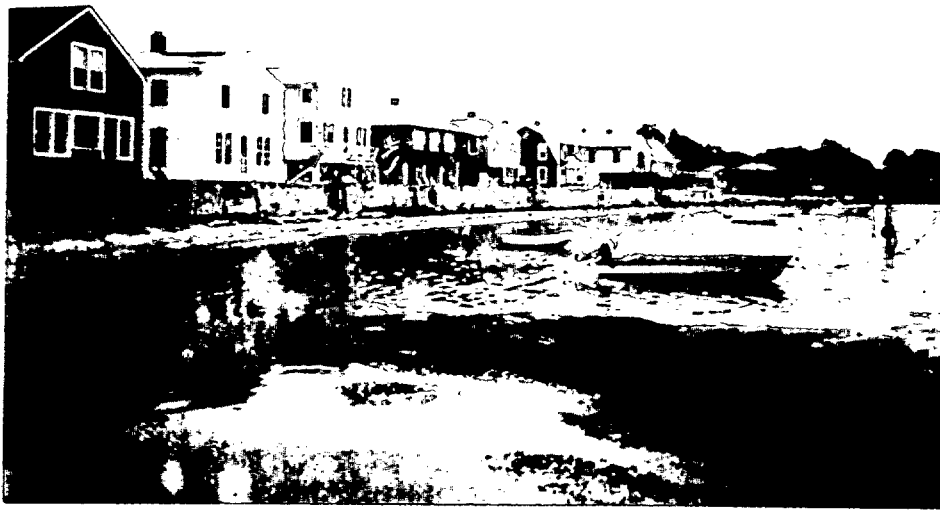
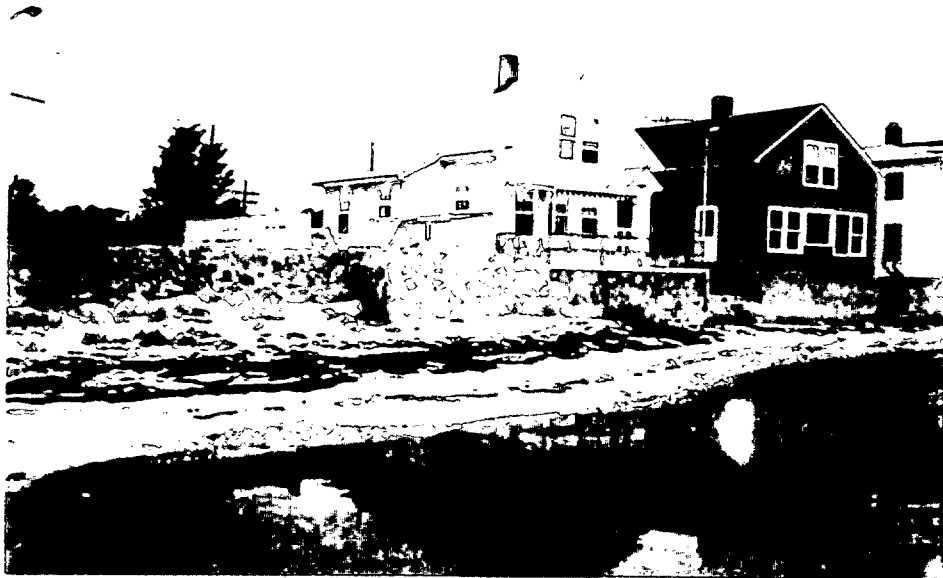
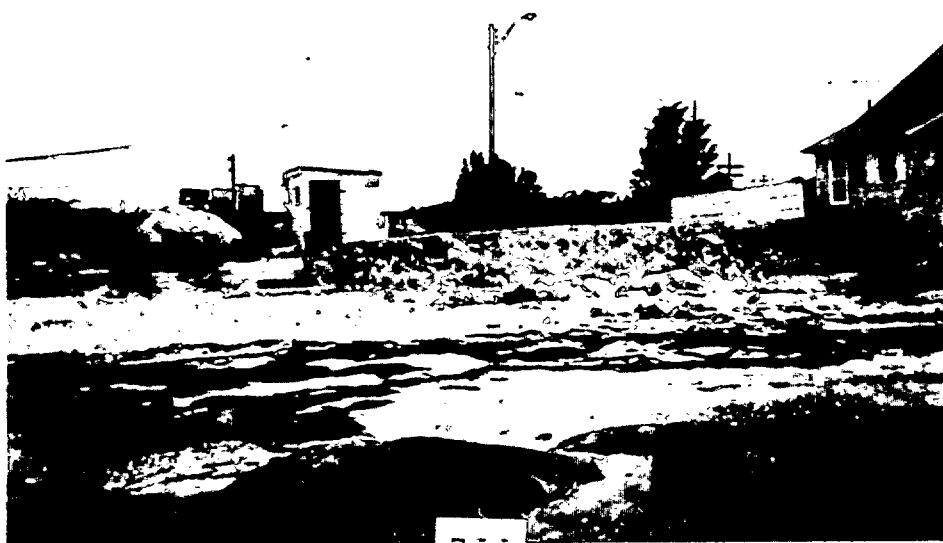
MY 15.00 #1

TYPE OF STRUCTURE: SEAWALLS-SERIES CONDITION: FAIR
MAIN FUNCTION : PROTECTS 9 PRIVATE HOMES; RETAINS LAND AND EROSION
MATERIAL :

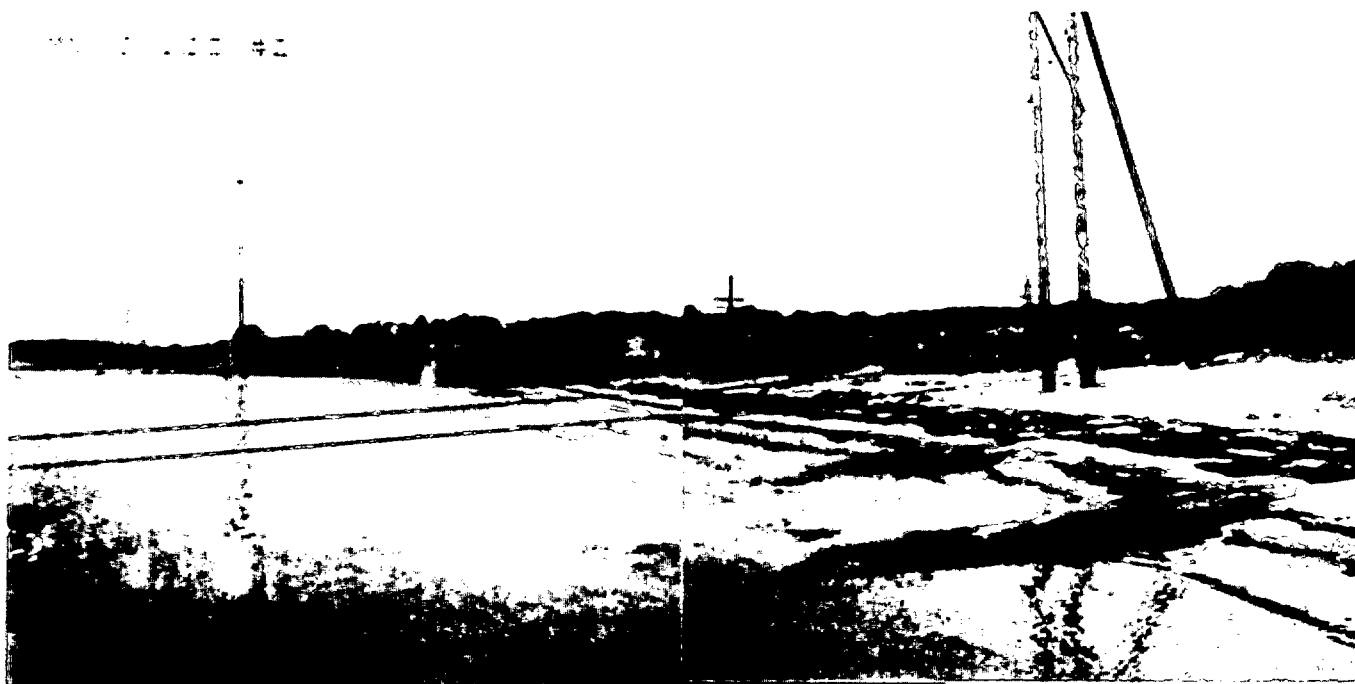
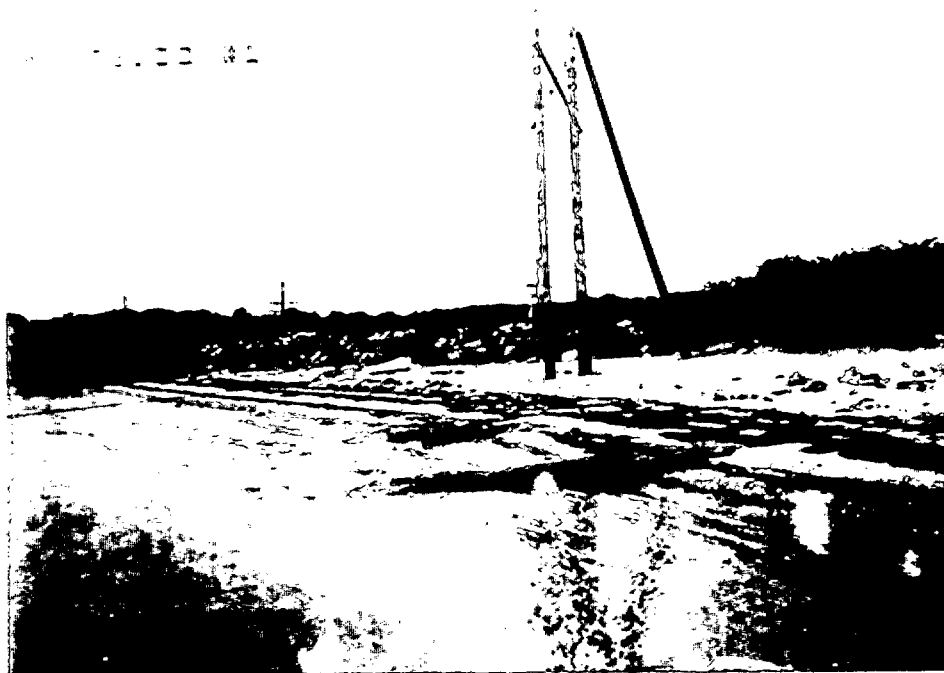
TYPE OF STRUCTURE: REVETMENT CONDITION: GOOD
MAIN FUNCTION : RR BRIDGE/PROTECTS SLOPE
MATERIAL :

#1 ROLL 4 NEG 27 BRIDGE LOOKING WEST
#2 ROLL 5 NEG 1-2 PANORAMIC VIEW OF BRIDGE LOOKING WEST
#3
#4
#5

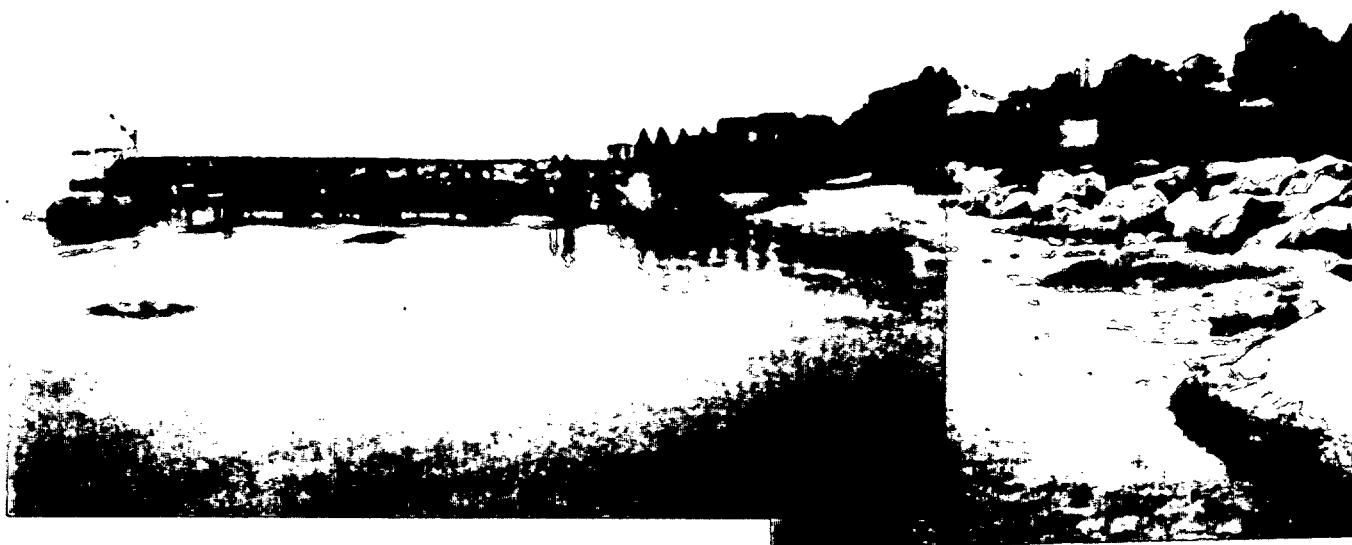
NY 27.12 41

TYPE OF STRUCTURE: WALL/GROIN/DOCK CONDITION: GOOD
MAIN FUNCTION : RETAINS SAND ON SMALL BEACH AND MAINTAINS BACKYARD
MATERIAL : ROCK

BOULDERS APPEAR TO BE NATURALLY DEPOSITED. NEIGHBORS OBJECT
TO PRESENCE OF WALL BEC/IT RUINS NORMAL TIDAL ACTION & OBSTR
UCTS VIEW. ANDERSON DOCK ADJACENT TO SM., PRIVATE BEACH...

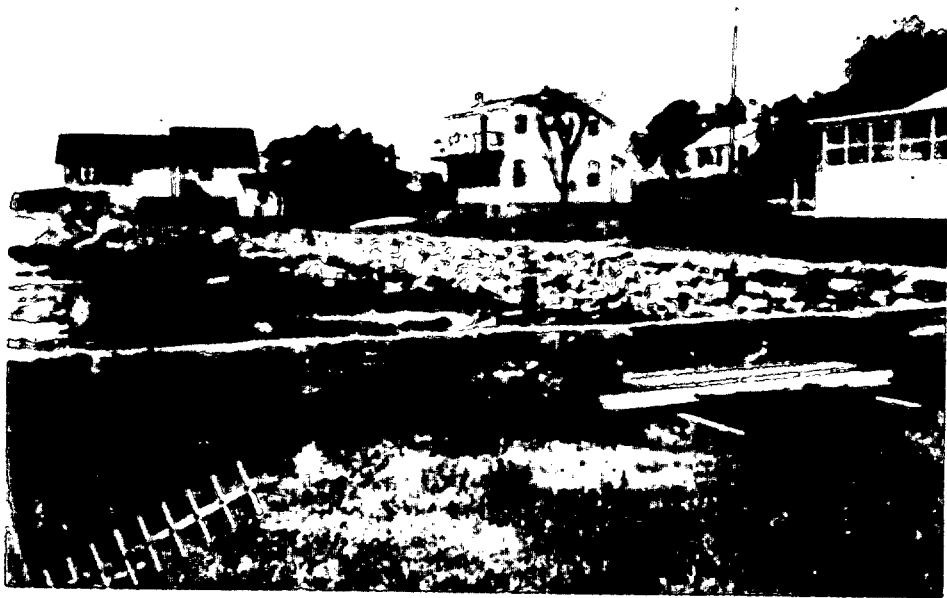
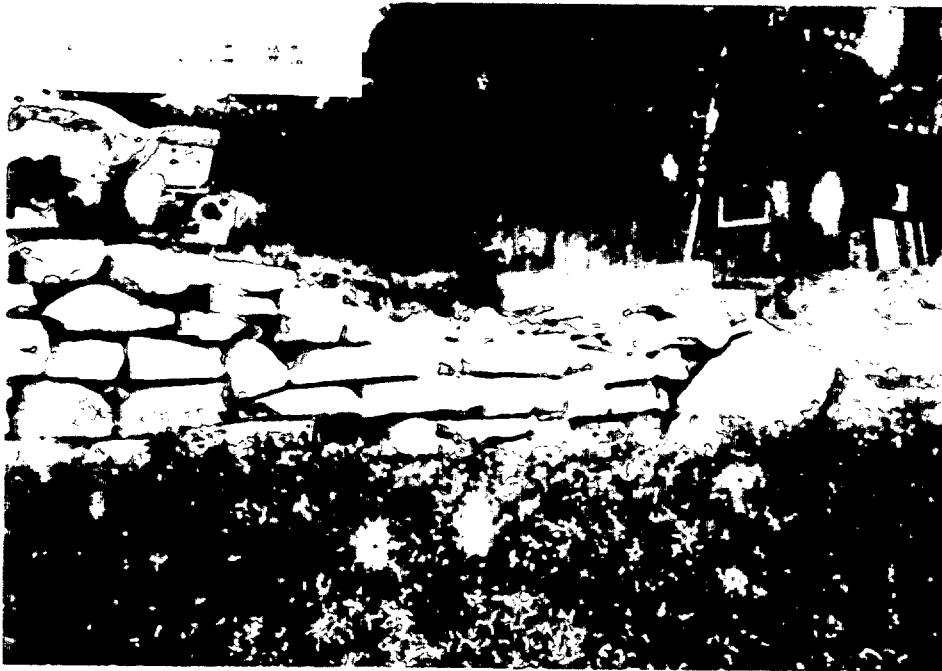
TYPE OF STRUCTURE: SEAWALL CONDITION: FAIR
MAIN FUNCTION : RETAINS PROPERTY; HURRICANE PROTECTION EROSION CON
MATERIAL : STONE

#1 ROLL 5 NEG 10 REVETMENT FROM ADJOINING PROP. TO NE LOOKING W
#2 NEG 11 SEC. OF REVETMENT DAMAGED BY HURRICANE
#3
#4
#5

SOME BACKSIDE SCOUR; 1978, PLAN AVAILABLE FROM TOWN OF STON-
INGTON - POWELL ENGINEER; PLAN SHOWING LAYOUT OF LOT; SEA-
WALL WITH SM. OPENING IN CENTER TO ALLOW ACCESS TO WATER.
